Stability problems effecting the performance of a full face tunnel boring machine in Istanbul – Baltalimani Tunnel

N. Bilgin & E. Nasuf

ABSTRACT: This paper is mainly concerned with the stability problems effecting the performance of a full face tunnel boring machine in Istanbul – Baltalimani sewerage tunnel being constructed in rock formations consisting of, limestone, carbonateferous shale, greywackee, siltstone and mudstone. The formations are strongly folded, the joints being generally vertical to bedding planes.

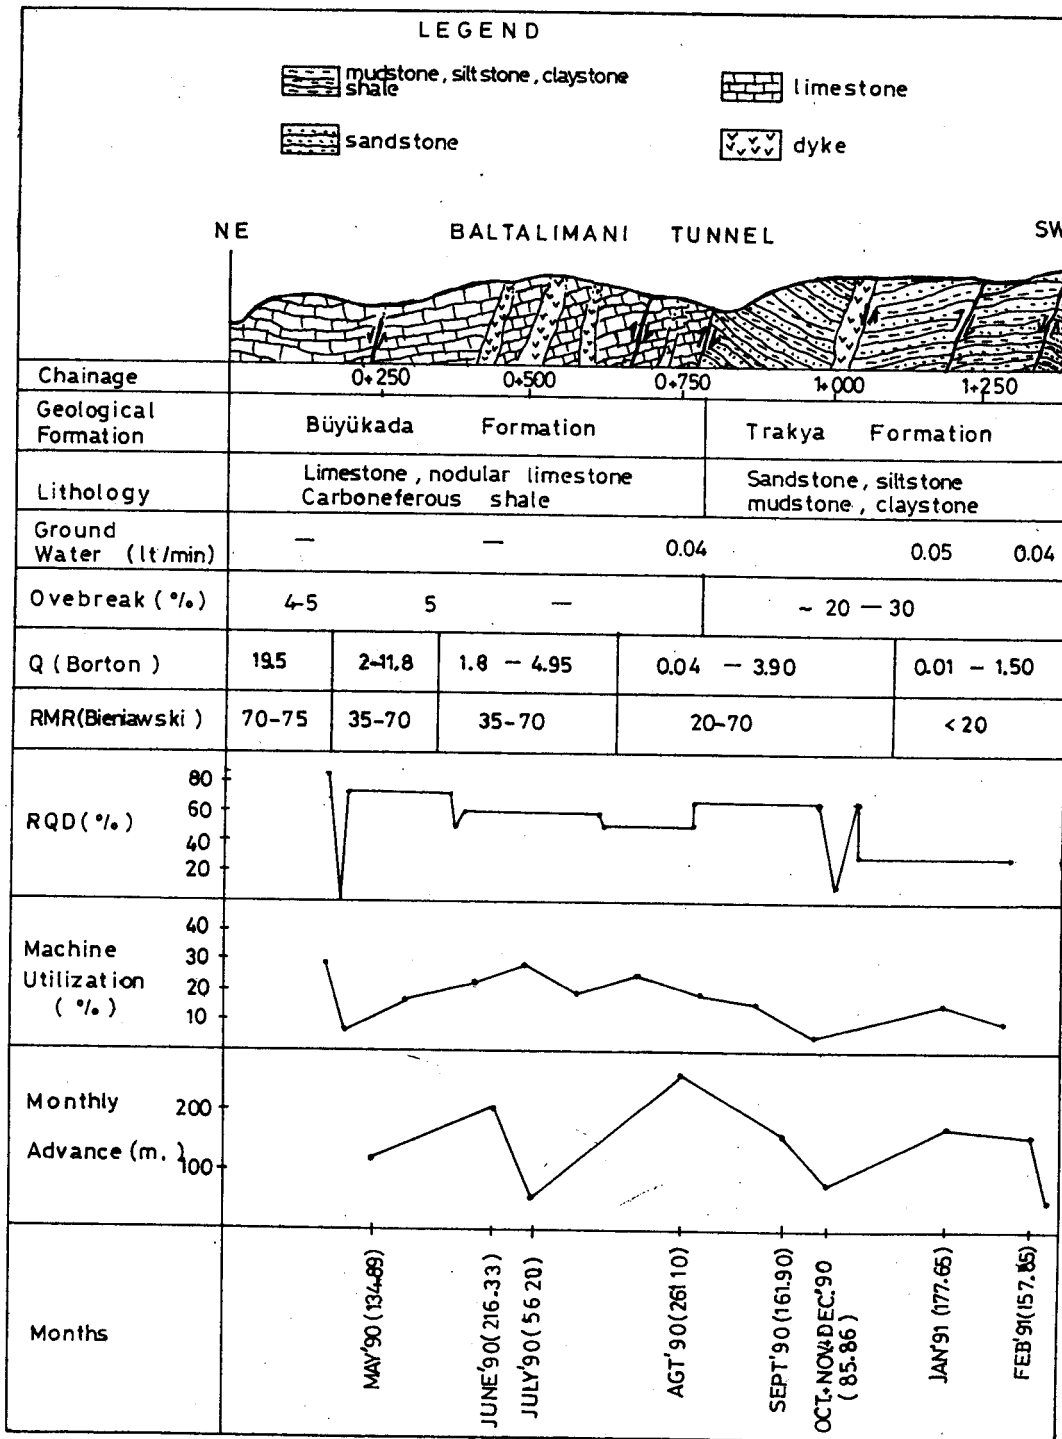
Fig.3 The summary of geological conditions and machine performance in Baltalimani Tunnel

Machine performance in Buyukada and Trakya Formation are summarized in Table 2 and Figure 3. Some data on geological conditions such as RQD, RMR, Q, overbreak and rock mass quality values are also given in Figure 3. As one can easily notice in this table, the machine utilisation in Trakya Formation is 4 times less than Buyukada Formation, the main reason of this fact being very bad ground conditions (Cigla,1991).

The support of the caverns at crown and sidewalls took 74% of the machine downtime during the excavation through Trakya Formation. High pressing loads of gripper

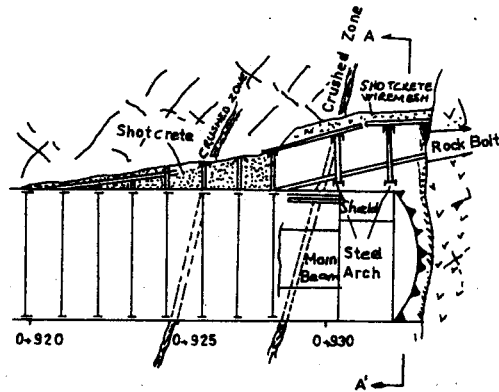
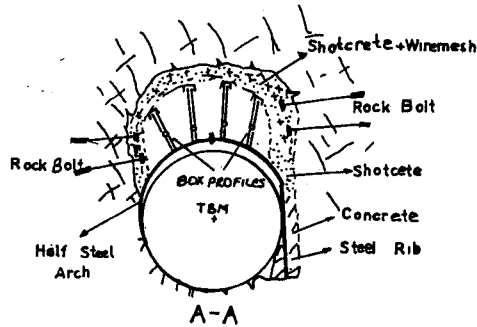
Fig.4 Collapse and support system used between chainage 0+928-0+935

5.1 Collapse Between Chainage 0+895-0+935

The collapse occurred in very crushed and fractured interbedded siltstone-mudstone zone. It started from right shoulder and enlarged towards the left shield of the machine. The support system used in this collapse area is described in Figure 4.

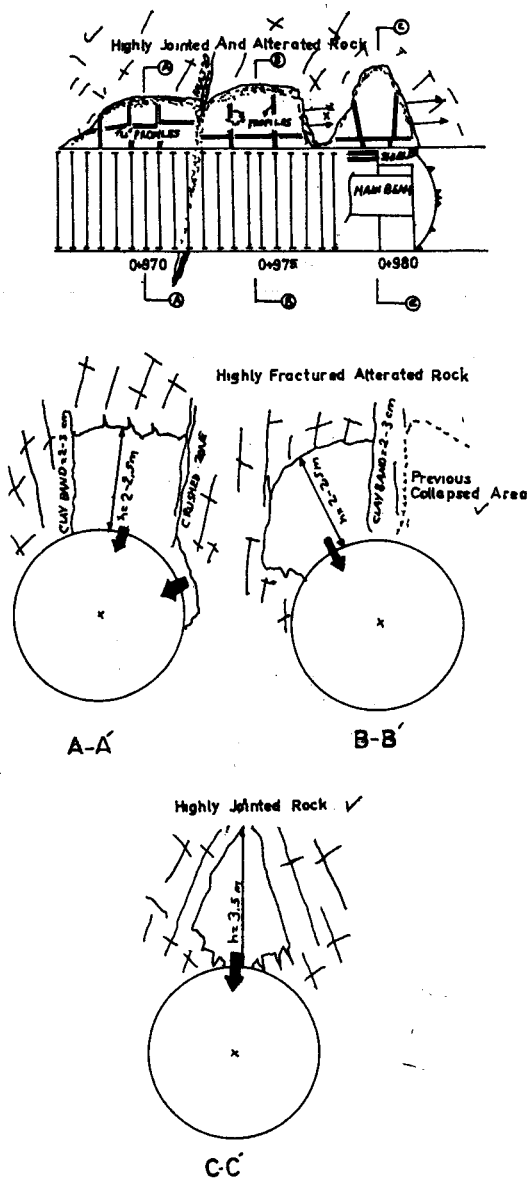
Fig. 5 The Collapse Between Chainage 0+965-0+982

The collapse happened in mudstone of Trakya Formation which is green to greenish gray coloured, moderately hard, heavily jointed and fractured, with clay filled shear zones. The fault zone having 20-30cm clay gauge, making an angle of 40-50° with tunnel route caused the collapse in this area. Rock material of 40-50m³ filled the face and buried the cutterhead of the machine. A schematic presentation of the collapse area and the support system used is given in Figure 5.

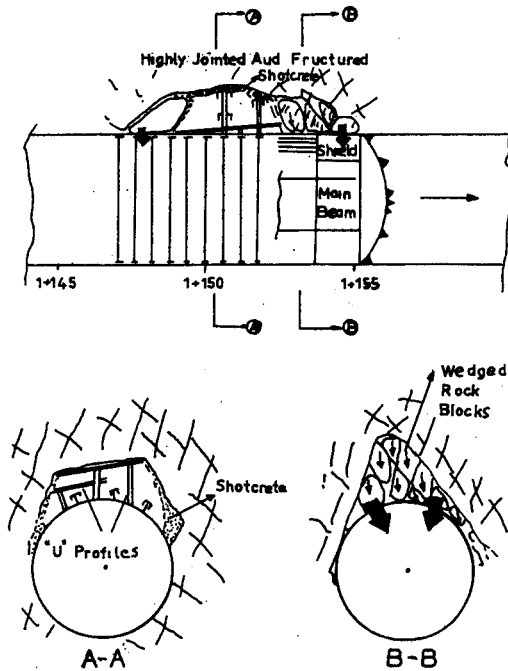
Fig. 6 Wedged rock blocks between chainage 1+148-1+155

Highly jointed and fractured rock with clay filled siltstone, mudstone of Trakya Formation were encountered in this area. Rock blocks collapsed on the shield due to the presence of joint sets as seen in Figure 6.
