Stability problems effecting the performance of a full face tunnel boring machine in Istanbul – Baltalimani Tunnel

N. Bilgin & E. Nasuf

ABSTRACT: This paper is mainly concerned with the stability problems effecting the performance of a full face tunnel boring machine in Istanbul – Baltalimani sewerage tunnel being constructed in rock formations consisting of, limestone, carbonateferous shale, greywackee, siltstone and mudstone. The formations are strongly folded, the joints being generally vertical to bedding planes.

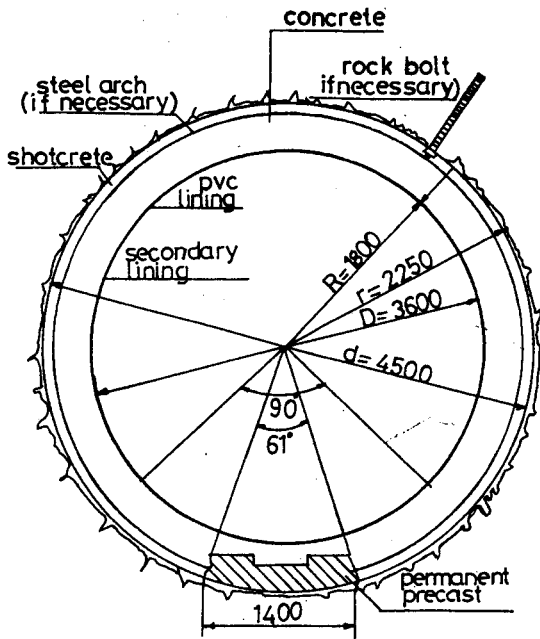
Fig.2 The support used in Baltalimani Tunnel

A typical tunnel support used in Baltalimani is shown in Figure 2. Rock bolts, steel arches and shotcrete were immediately installed after the excavation. Later, the secondary lining has a PVC liner to protect the concrete from corrosion by hydrogen sulphide gases.
